# Plat of Survey

Date: May 29, 2008  
For: Double EE Pheasant Ranch  
c/o Ron Erickson  
Route 3  
McPherson, KS  
67460

Parcels located in the North One Half (1/2), Southwest One Quarter (1/4), Section 21, T18S-R3W Pg. 3/3

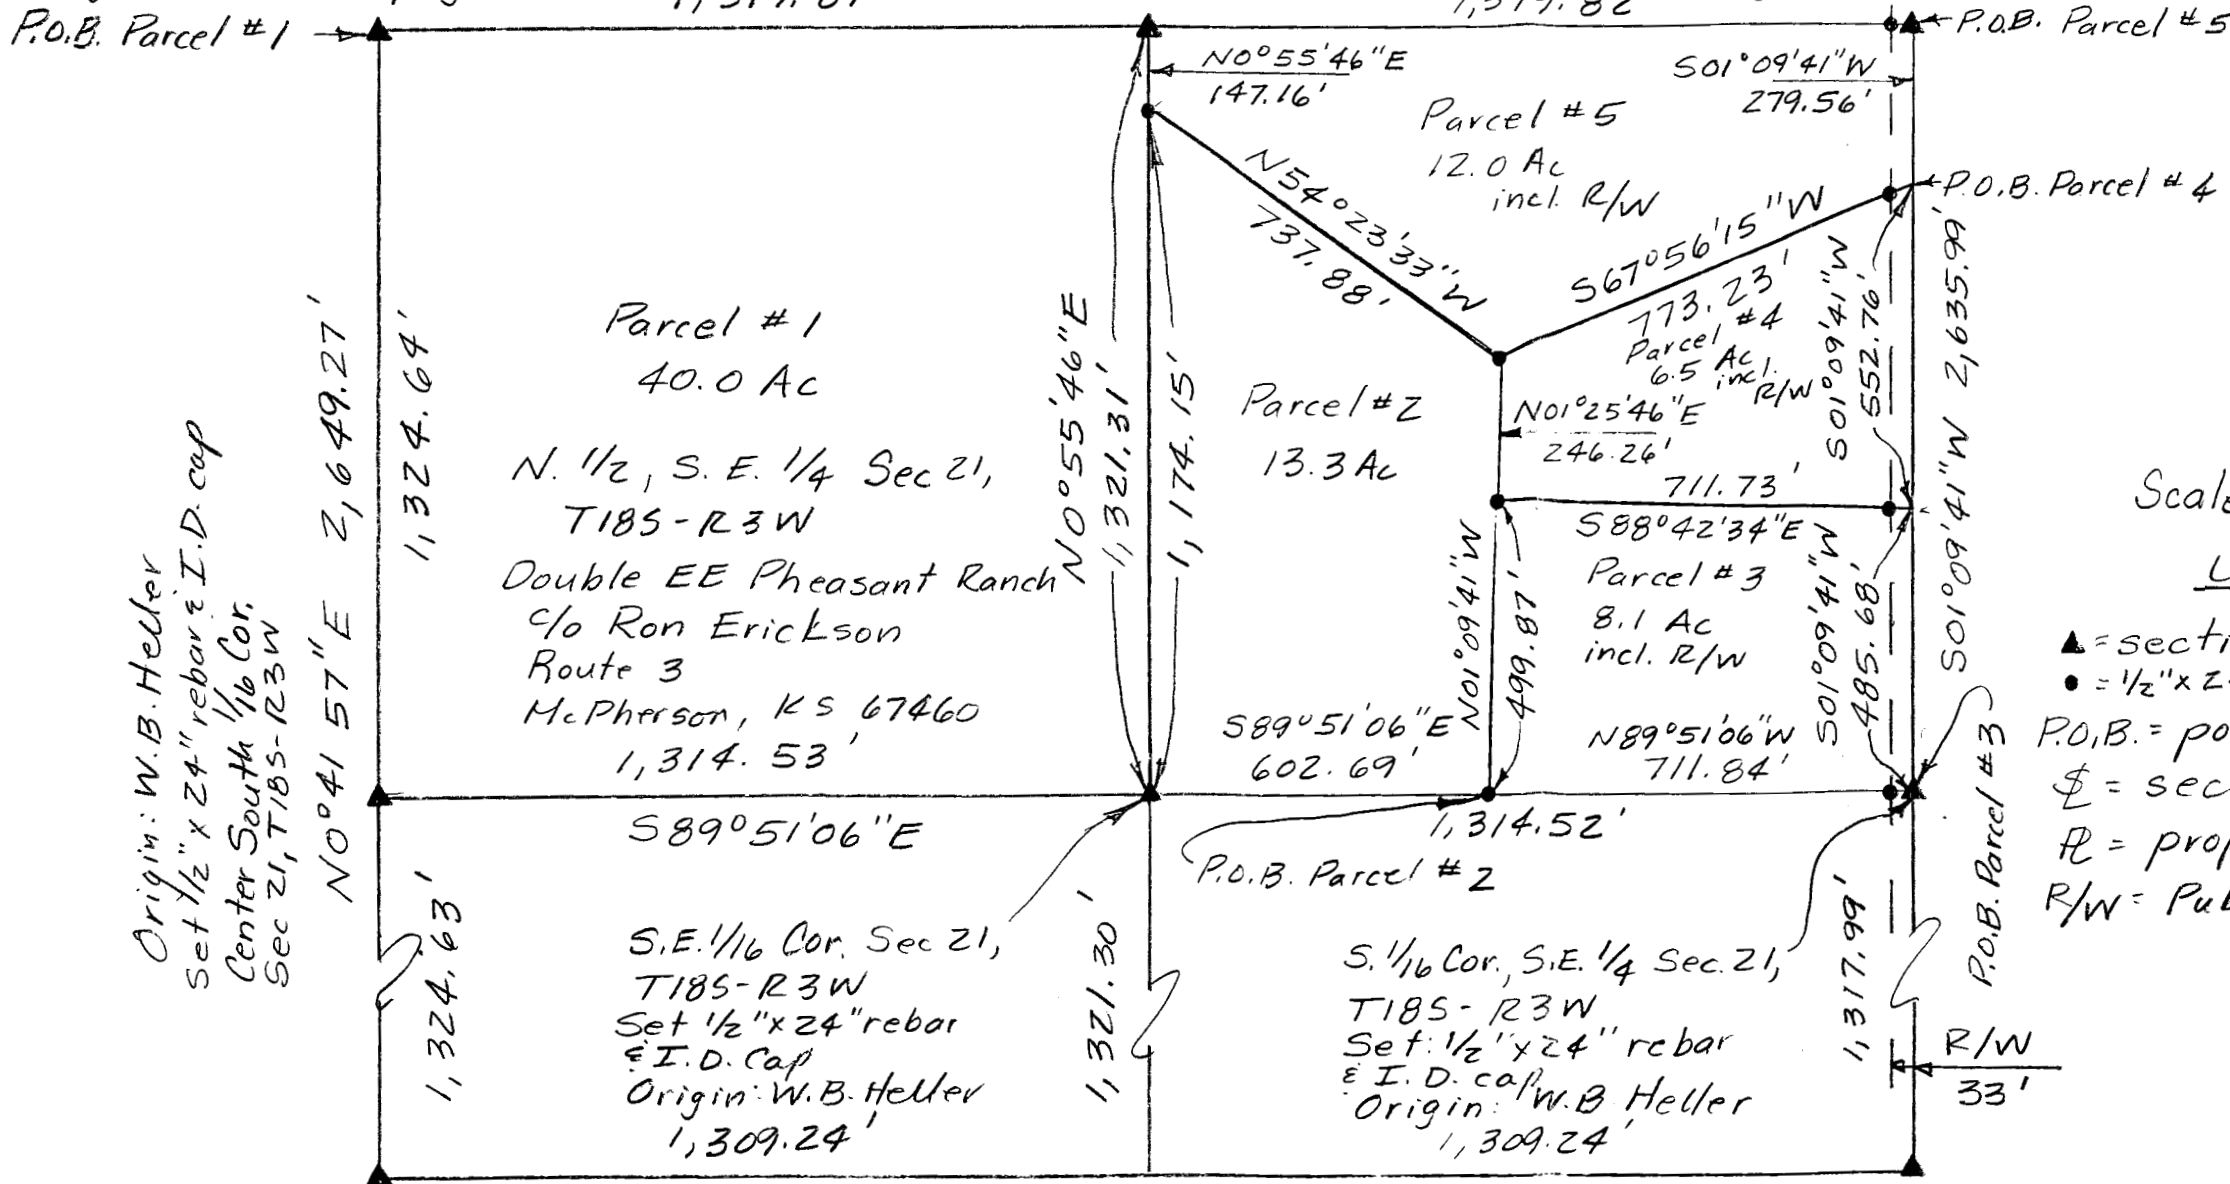
Center Corner Sec 21, T18S-R3W  
Found: 5/8" rebar  
Origin: Durr Surveying  
P.O.B. Parcel #1

E. 1/4 Cor., Sec. 21, T18S-R3W  
Found: "60D" spk.  
Origin: unknown

S. 1/4 Cor., Sec 21, T18S-R3W  
Found: 5/8" rebar  
Origin: unknown

S.E. Cor., Sec 21, T18S-R3W  
Found: 5/8" rebar  
Origin: unknown
