Address: 875 24th Avenue, McPherson, KS

**McPherson Engineering
& Land Surveying Services**
PO Box 662
McPherson, KS 67460
620-241-0950

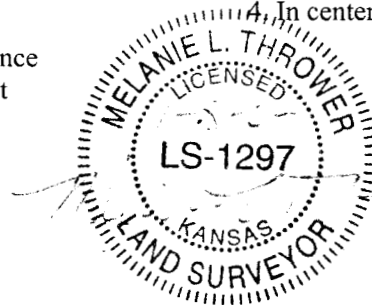
Point of Beginning

NE Corner 24-T20S-R2W

Found 5" Rebar- Origin Unknown -Placed ID cap

1. 31.25' SW to top Tel. Ped.
2. 43.55' NW to spike in fence post
3. 177.9' ESE to spike in power pole
4. In center of intersection

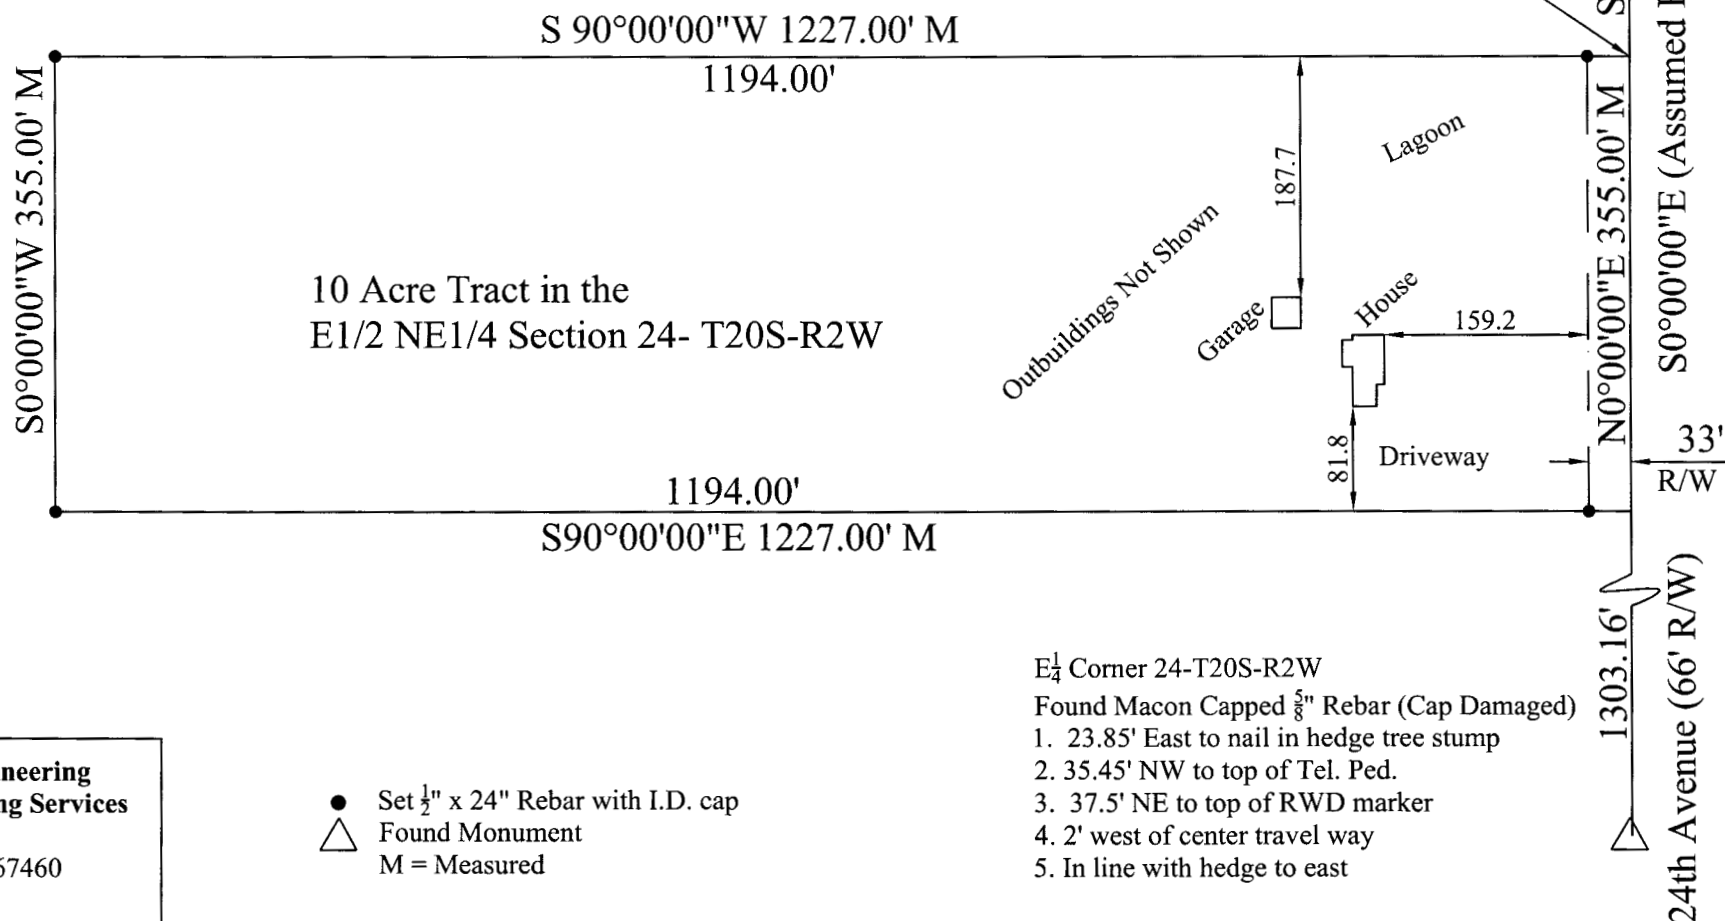
Scale 1"=150'

E $\frac{1}{4}$ Corner 24-T20S-R2W

Found Macon Capped $\frac{5}{8}$ " Rebar (Cap Damaged)

1. 23.85' East to nail in hedge tree stump
2. 35.45' NW to top of Tel. Ped.
3. 37.5' NE to top of RWD marker
4. 2' west of center travel way
5. In line with hedge to east
