Heller Boundary Surveys, W. B. Heller, <sup>Plat of Survey</sup> L.S. 1202, 863 S. 9<sup>th</sup>, Salina, KS 67401 Ph: 1-620-245-8023

Section 25, T17S-R3W

For: Kent Schmidt  
1492 Janasu Road  
McPherson, KS  
67460

Date: 6-17-2008

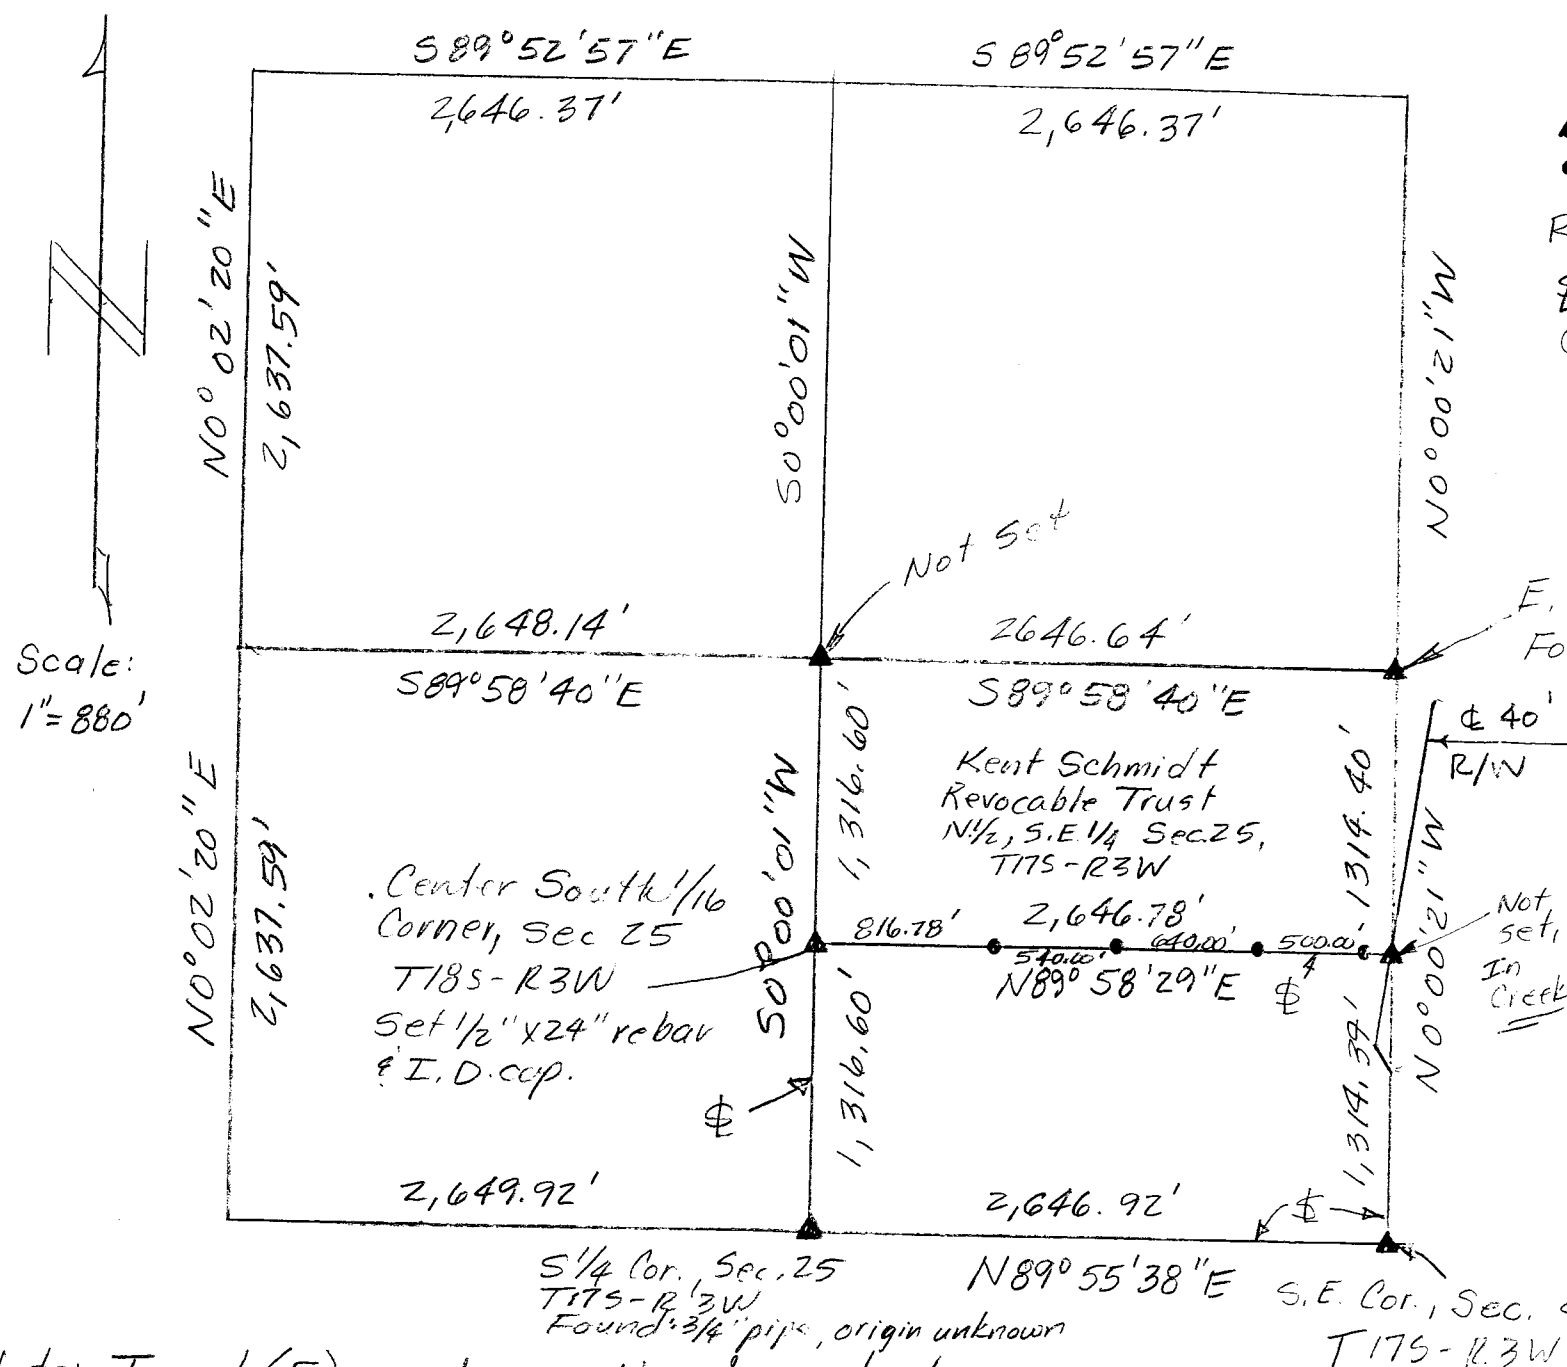
Note: The points set on the line between the N.  $\frac{1}{2}$  E. S.  $\frac{1}{2}$  of the S.E.  $\frac{1}{4}$  of Sec 25, T17S-R3W are at the C.S.  $\frac{1}{16}$  Cor., then 816.78' East on  $\frac{1}{16}$  line; then 540.00' East on  $\frac{1}{16}$  line; then 640.00' East on  $\frac{1}{16}$  line; then 500.00' on  $\frac{1}{16}$  line to a point  $\dagger$  on the West side of 18<sup>th</sup> Avenue.

Note: I set (5) points on the line between the N. 1/2 & S. 1/2 of the S.E. 1/4 of Sec. 25, T17S-R3W.

S.E. Cor., Sec. 25,  
T17S-R3W

Found: 5/8" rebar & I.D. cap

Origin: Forgy Surveying on the S. & E. side of the S. E 1/4 matched Forgy's plat.

Note: Forgy Surveying broke Section 25, T17S-R3W down in March of 1979. The distance and bearings on the S. & E. side of the S. E 1/4 matched Forgy's plat. Pg. 1/1
