Note: This survey is a retracement and client requests no pins be set on the abandoned Union Pacific Railroad right of way.

Date: August 1, 2022

For: Salvatore and Annamarie Brancaccio  
4511 Rockland Drive  
Arlington, TX 76016

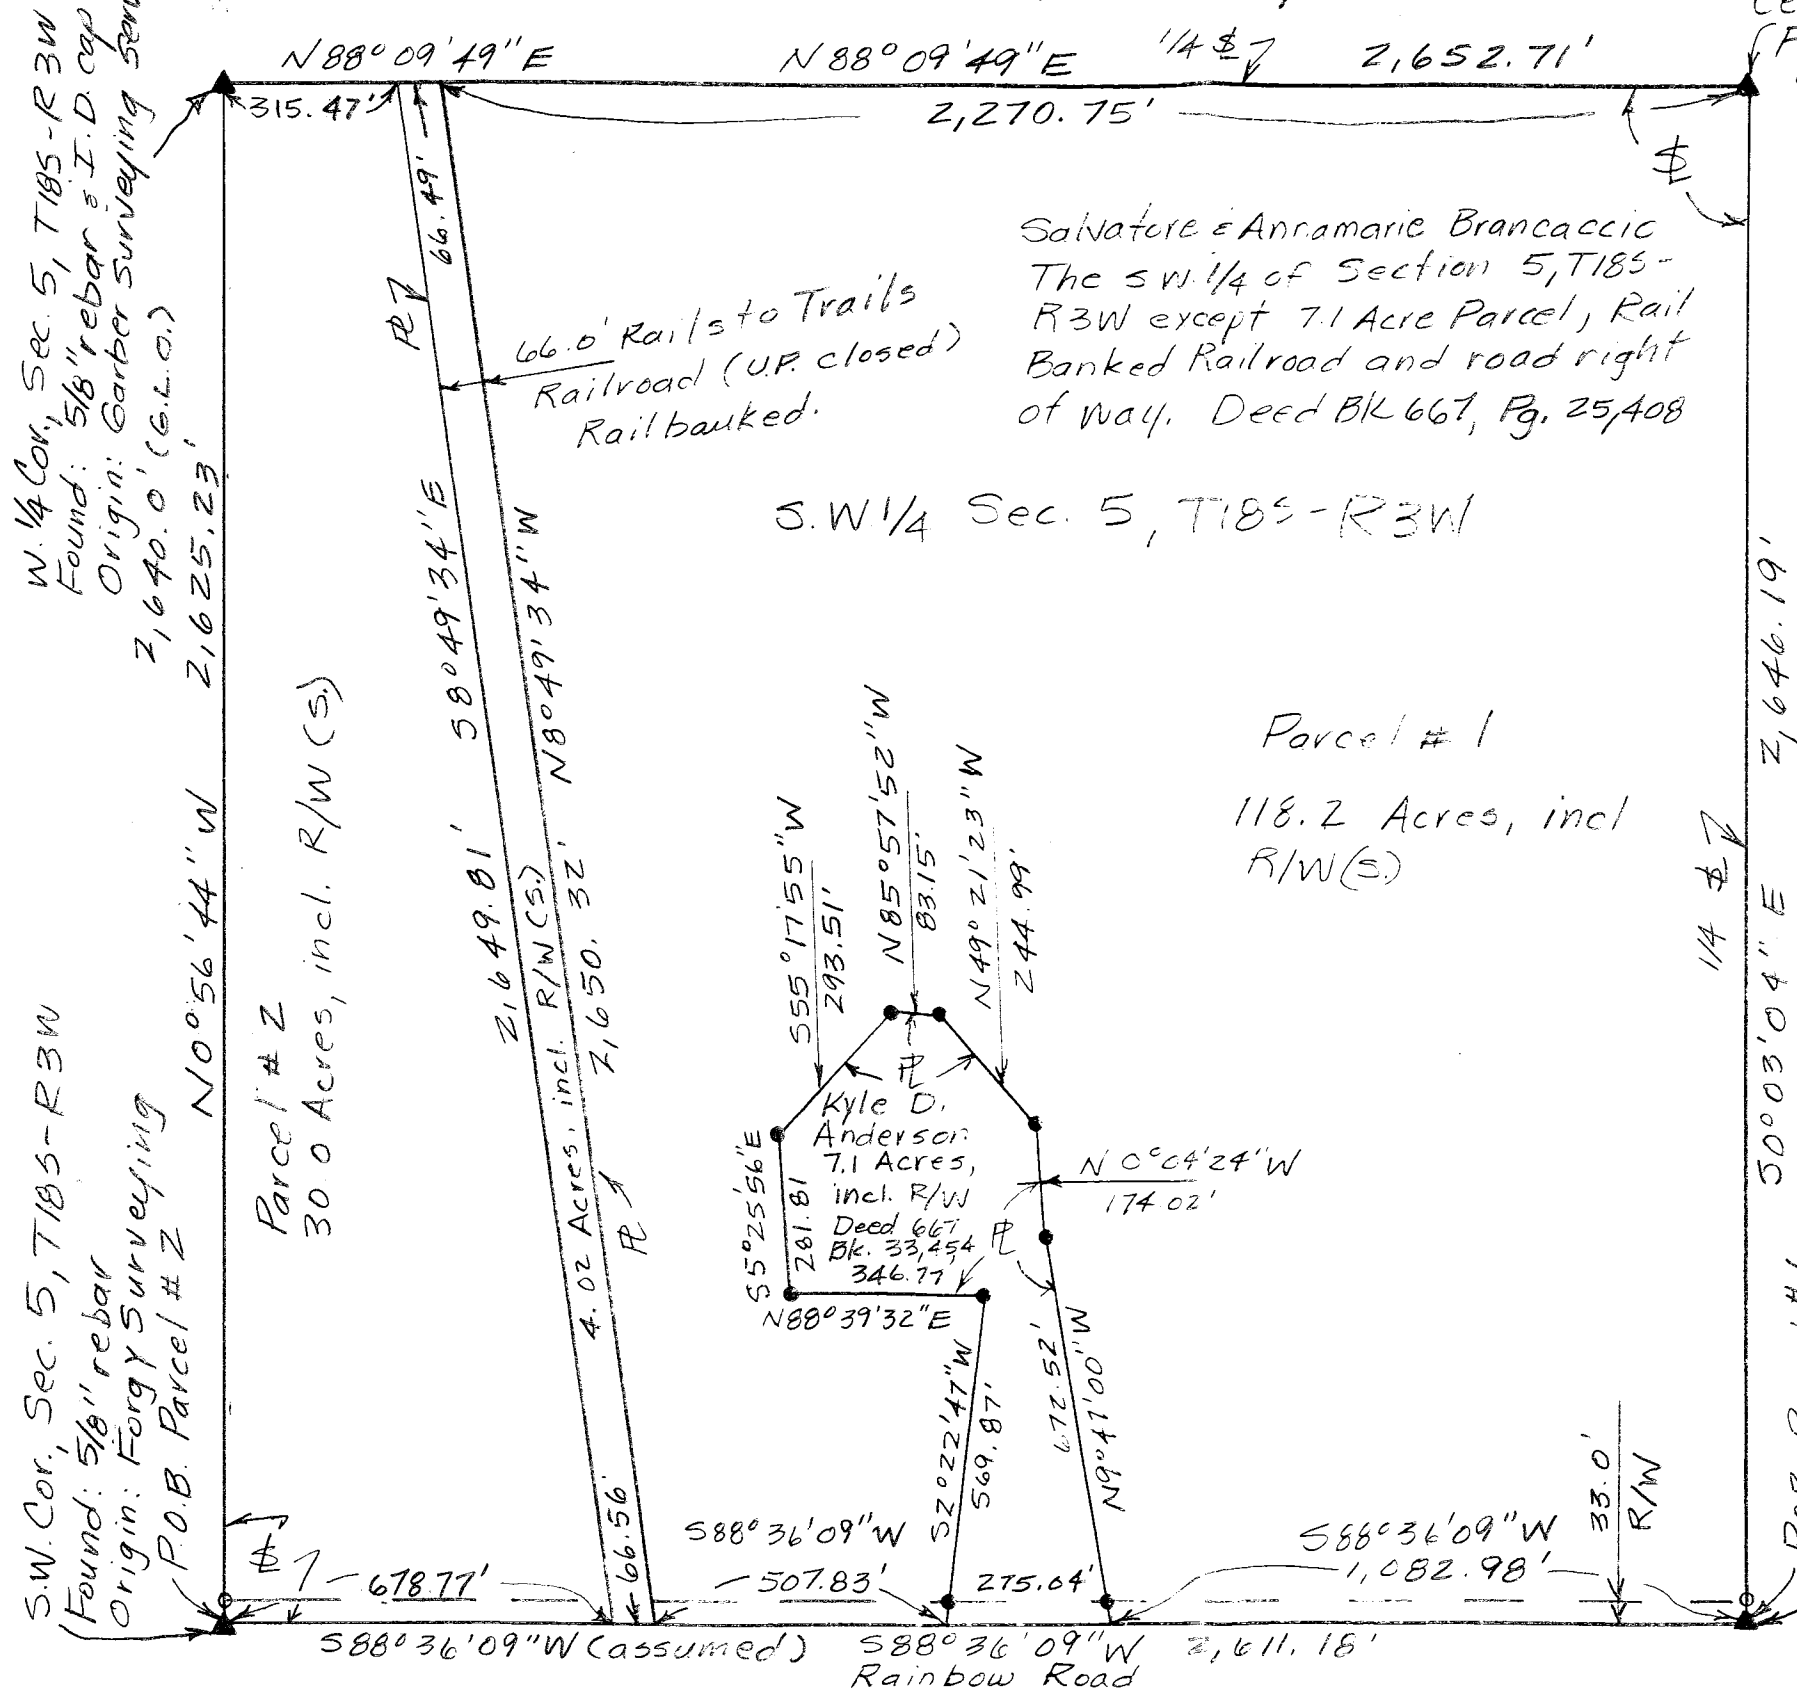
S.W. Cor., Sec. 5, T18S-R3W  
(Found: 5/8" rebar  
Origin: Forgy Surveying  
P.O.B. Parcel #2

W. 1/4 Cor., Sec. 5, T18S-R3W  
(Found: 5/8" rebar & I.D. cap  
Origin: Garber Surveying Service  
2,640.0' (G.L.O.)

Center Cor., Sec. 5, T18S-R3W  
(Found: 5/8" rebar  
Origin: Garber Surveying Service

S. 1/4 Cor., Sec. 5, T18S-R3W  
(Found: 5/8" rebar  
Origin: Garber Surveying Service
