Heller Boundary Surveys, W. B. Heller, L.S. 1202, 863 S. 9<sup>th</sup>, <sup>Flat of Survey</sup> Salina, KS 67401 Ph: 1-620-245-8023

Section 25, T17S-R3W

For: Kent Schmidt  
1492 Janasu Road  
McPherson, KS  
67460

Date: 6-17-2008

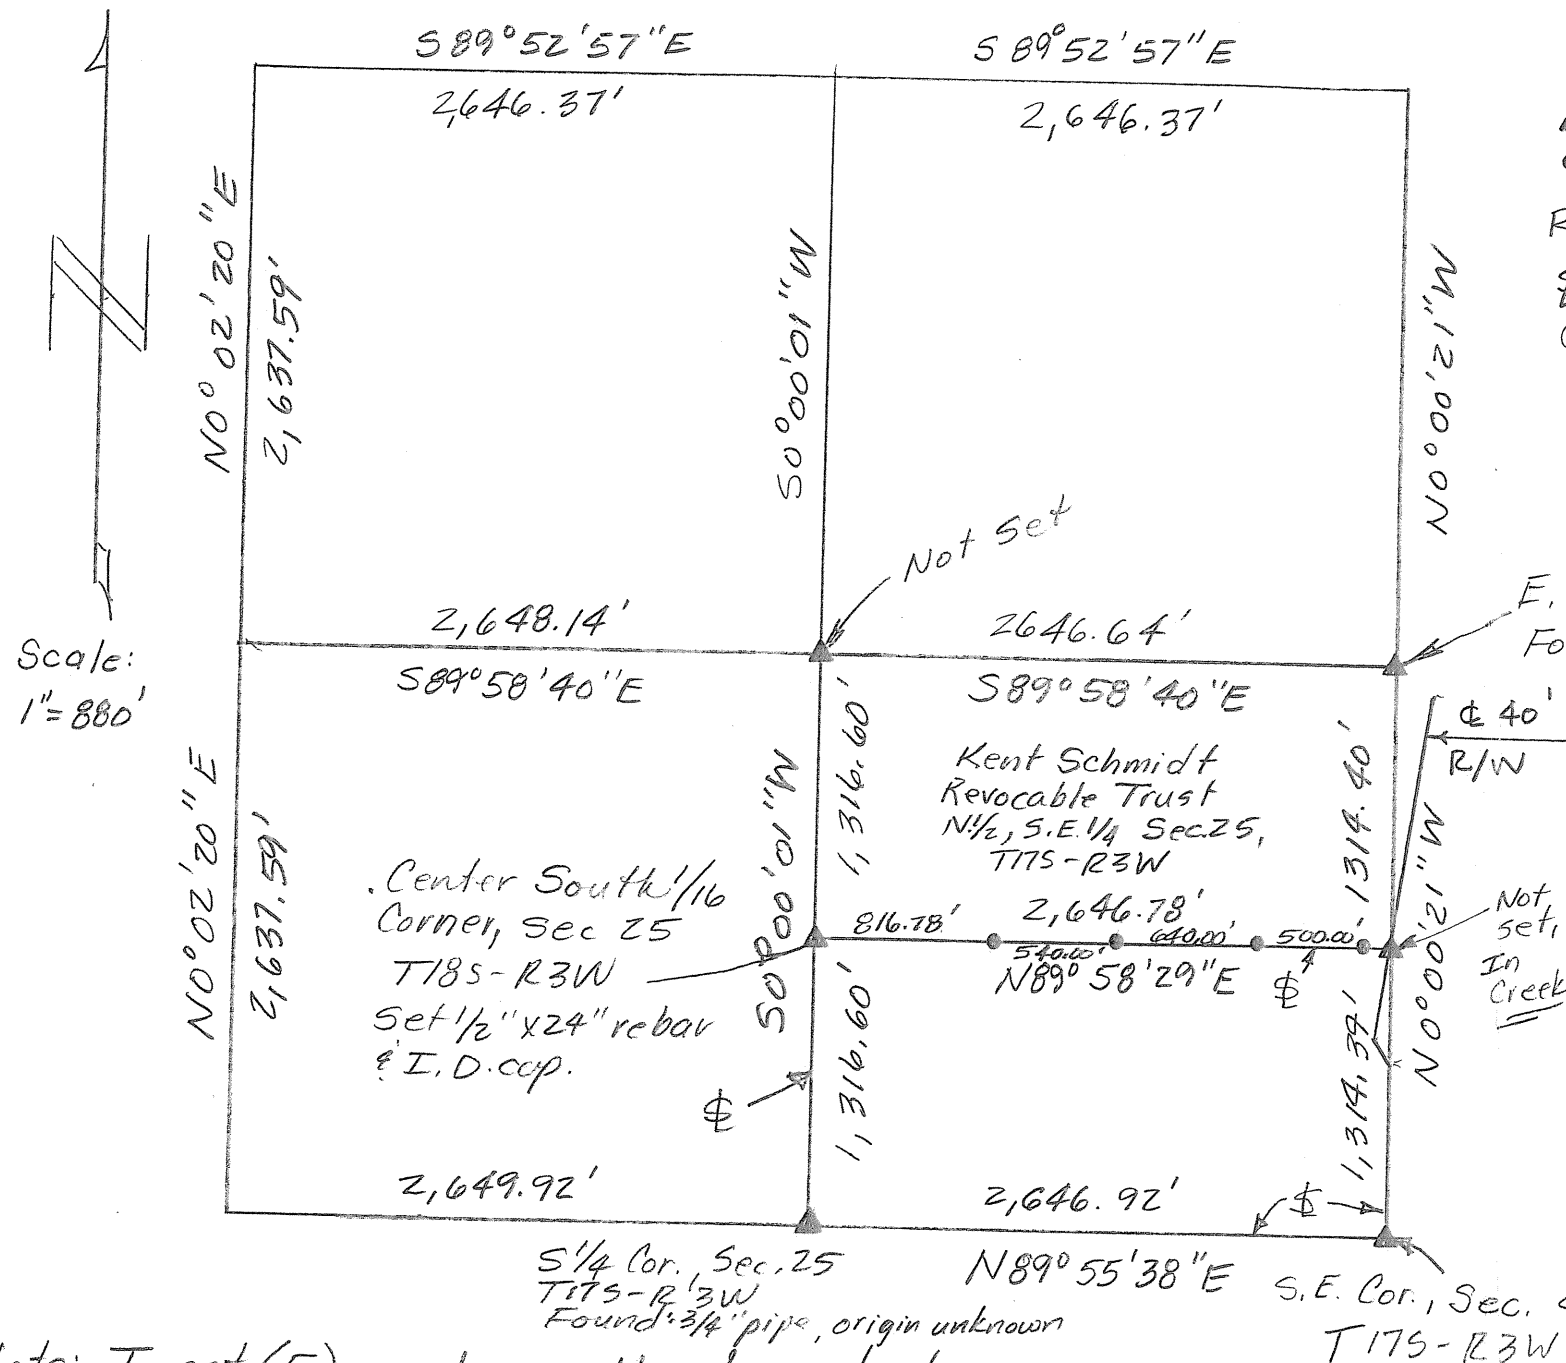
Note: The points set on the line between the N.  $\frac{1}{2}$  & S.  $\frac{1}{2}$  of the S.E.  $\frac{1}{4}$  of Sec 25, T17S-R3W are at the C.S.  $\frac{1}{16}$  Cor., then 816.78' East on  $\frac{1}{16}$  line; then 540.00' East on  $\frac{1}{16}$  line; then 640.00' East on  $\frac{1}{16}$  line; then 500.00' on  $\frac{1}{16}$  line to a point  $\dagger$  on the West side of 18<sup>th</sup> Avenue.

Note: I set (5) points on the line between the N.  $1/2$  & S.  $1/2$  of the S. E.  $1/4$  of Sec. 25, T17S-R3W.

S.E. Cor., Sec. 25,  
T17S-R3W

Found: 5/8" rebar & I.D. cap

Note: Forgy Surveying broke Section 25, T17S-R3W down in March of 1979. The distance and bearings on the S. & E. side of the S. E 1/4 matched Forgy's plat. Pg. 1/1
