# Plat of Survey

Heller Boundary Surveys, W. B. Heller, L.S. 1202, 863 S. 9<sup>th</sup>, Salina, KS 67401 Ph: 1-620-245-8023

Date: October 1, 2008

For: Howard H. and Joyce E. Hall  
1007 Darlow Drive  
McPherson, KS 67460

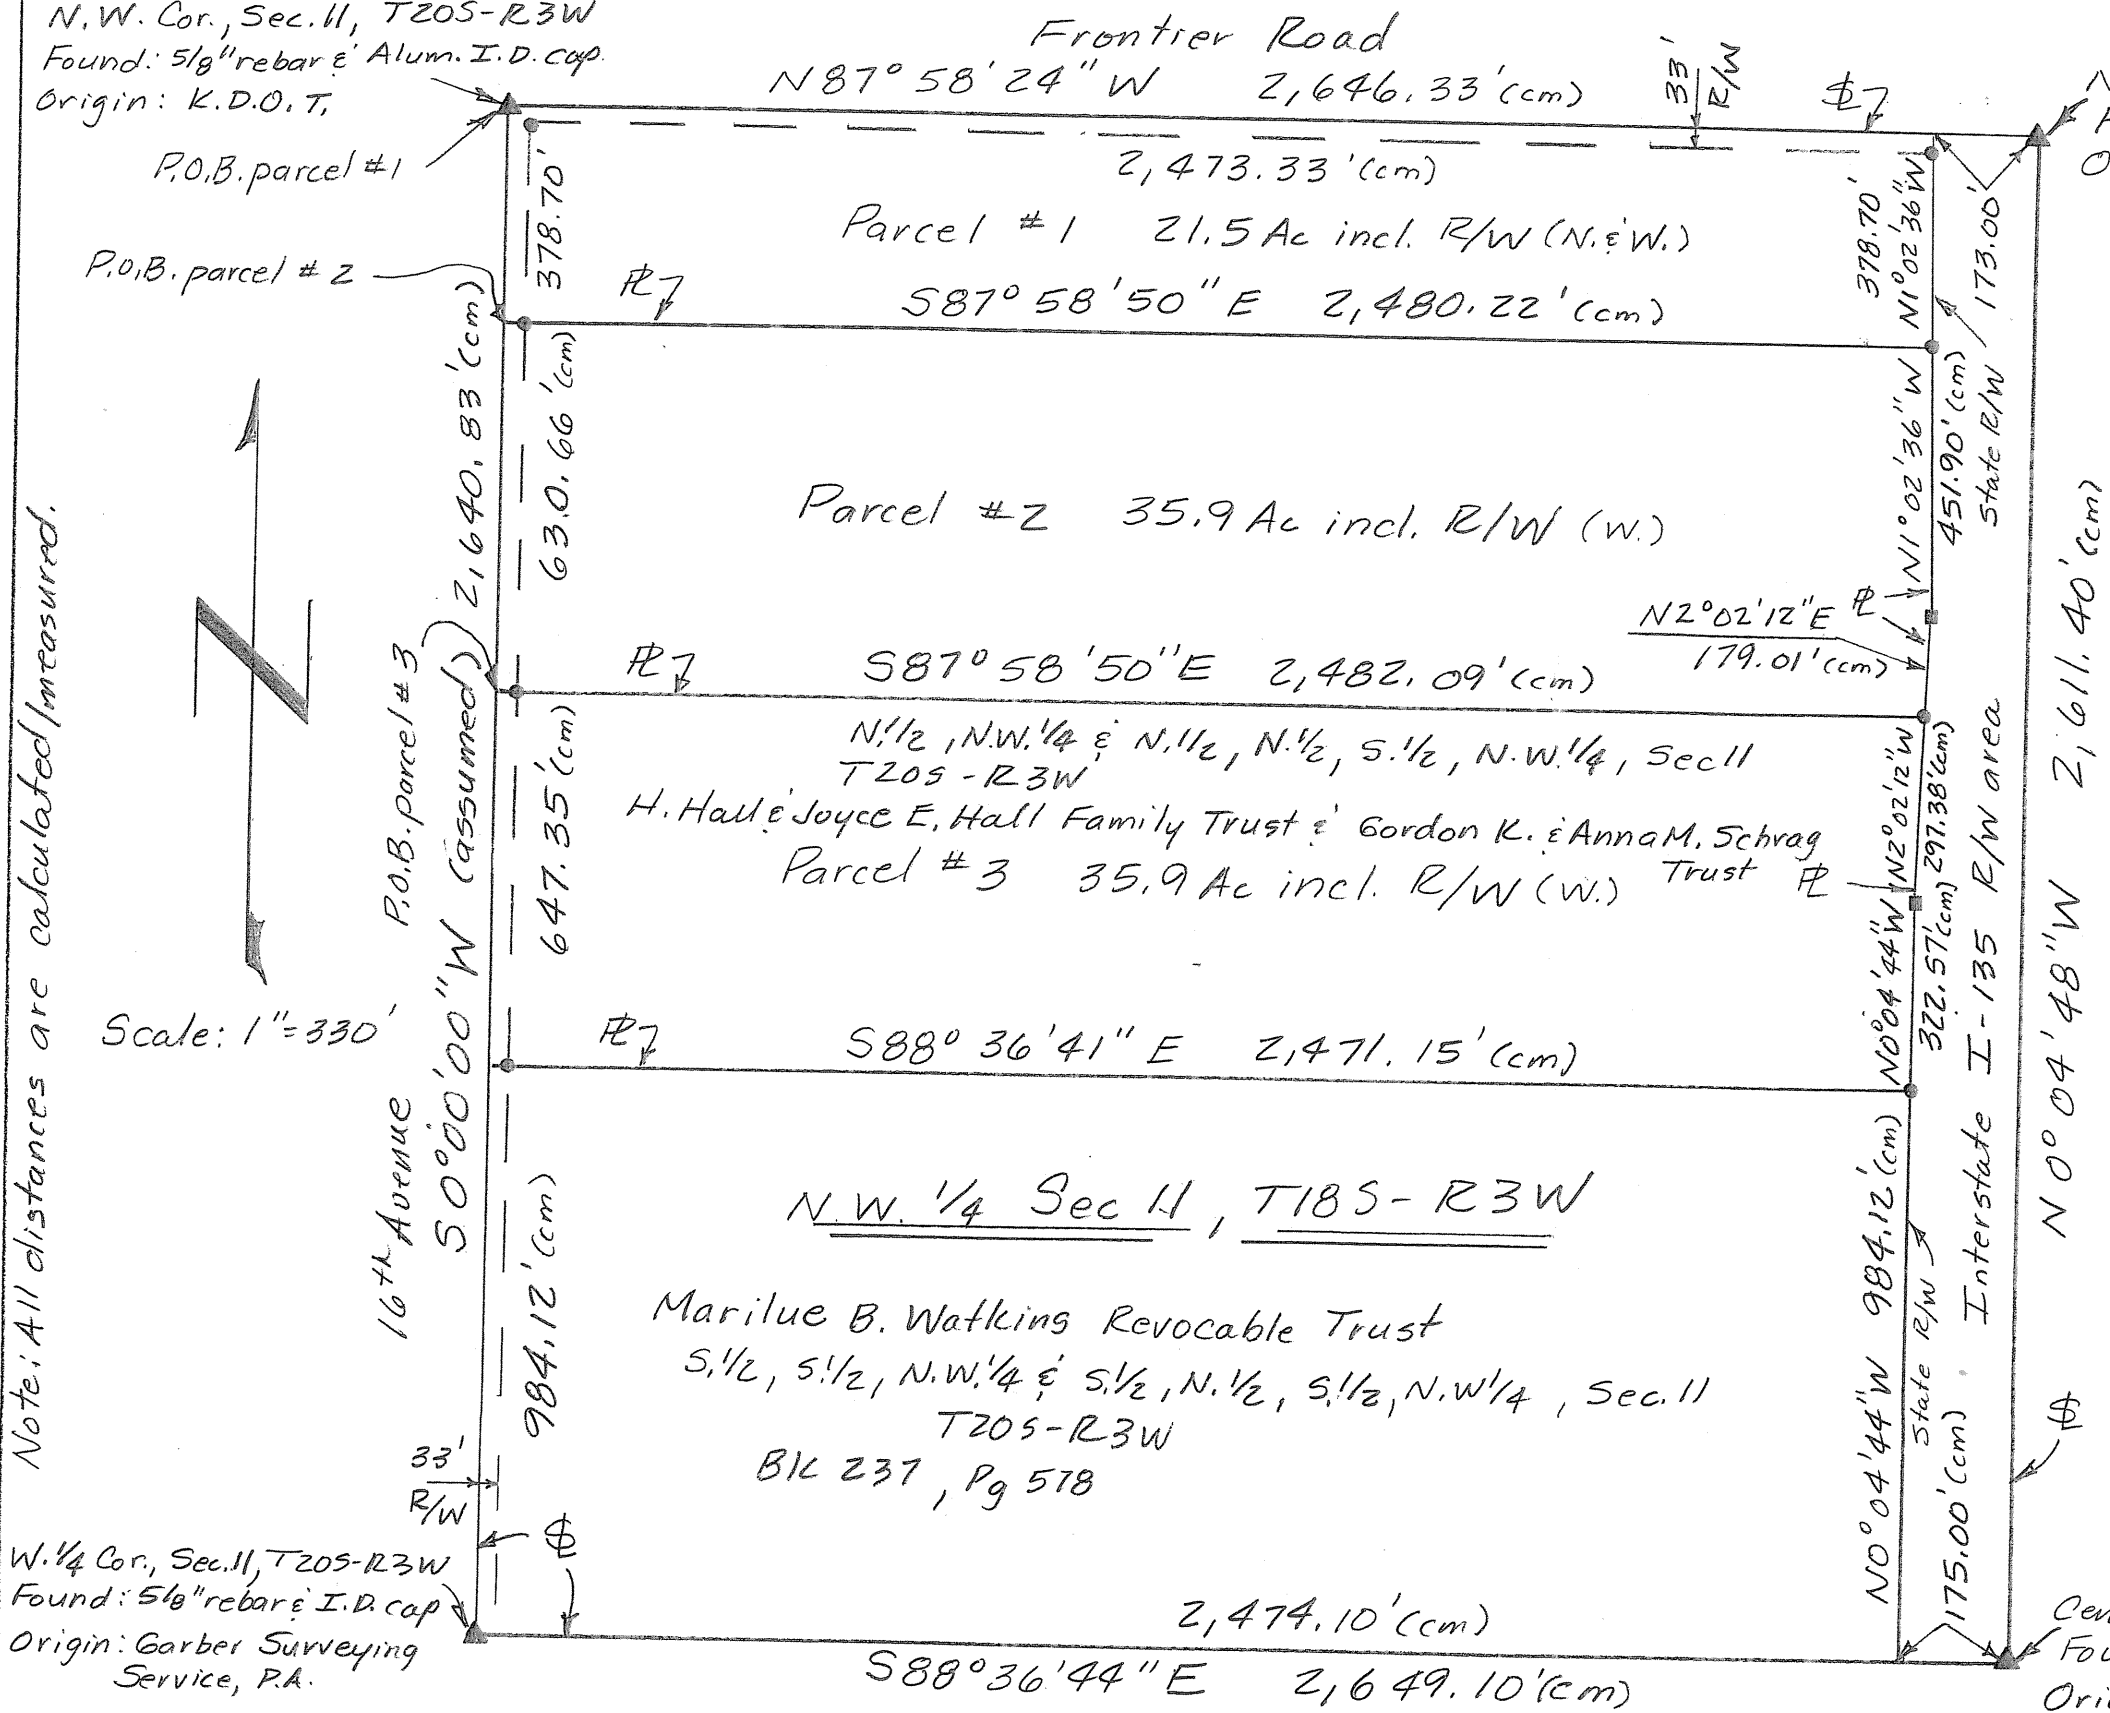
N.W. Cor., Sec. 11, T205-R3W  
Found: 5/8" rebar & Alum. I.D. cap  
Origin: K.D.O.T.

N. 1/4 Cor., Sec. 11, T205-R3W  
Found: 5/8" rebar & I.D. cap  
Origin: Garber Surveying Service, P.A.

Note: All distances are calculated/measured.

Scale: 1" = 330'

W. 1/4 Cor., Sec. 11, T205-R3W  
Found: 5/8" rebar & I.D. cap  
Origin: Garber Surveying Service, P.A.

Center Corner Section 11, T205-R3W  
Found: 5/8" rebar and I.D. cap  
Origin: Garber Surveying Service, P.A.
